# Position Tracking of Magnetic Flux Leakage Steel Floor Inspection Equipment inside Large Drained Out-of-Service Above-Ground Liquid Petrochemical Storage Tanks

SPEC, Swansea University, UK, Nov 2014

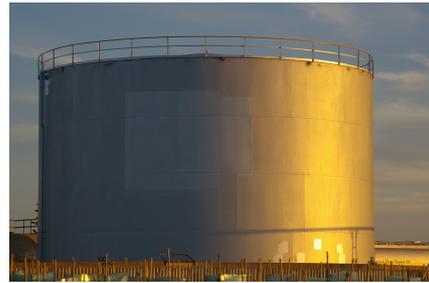
Figure 1: A typical AST this paper is concerned with (aprox. 12,600 oil barrels, found in North Fermantle, AU)

Large above-ground storage tanks (AST) such as in Fig. 1 are employed along supply lines of oil and liquid petrochemical products to handle fluctuations in supply and demand. Typical ASTs are sheets of carbon steel welded into vertical standing cylinders of 6 to 120 meter diameter that hold 100 to 10,000,000 oil barrels. Carbon steel corrodes with exposure to common outdoor conditions and the stored product, causing damage that risks leaks, product contamination and loss, work-site hazards, environmental disaster and ultimately limits the service life of ASTs.

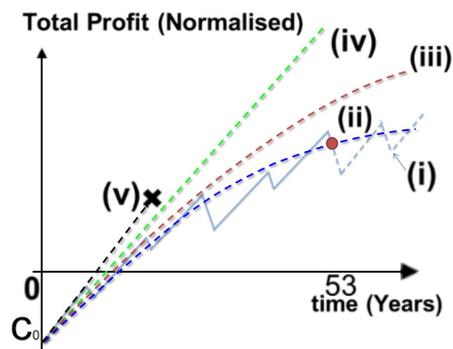
Figure 2: Operational profit profile offered by maintenance schemes:

- (i): Example AST
- (ii): Traditional out-of-service
- (iii): Enhanced out-of-service
- (iv): Continual in-service
- (v): No maintenance

Inspection and maintenance of ASTs is often costly and mandated by consumers and local governments. However, as Pearson, Mason and Priewald (2012) [1] show in Fig. 2, maintenance does increase the service life of ASTs and so increases the ultimate profit for the operator, and research has indicated that there is yet more improvement to be had from improving current methods and developing new ones.

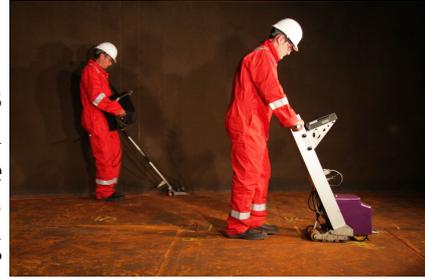
Figure 3: 2 technicians using MFL scanners inside an AST: the smaller handscan (left) and the more advanced FM3D (right)

First, a review of traditional maintenance procedures is conducted. This describes the use of MFL scanners on the interior faces of a drained and cleaned AST, the specific MFL scanning devices in question, and the conditions inside an AST that any position tracking system would have to work and cope with. As seen in Fig. 3, this can be summarised as a push trolley that moves in a very straight line and must be lifted with some effort to cross steps and turn, inside a dark, laterally spacious, closed, largely (but not entirely) featureless, dry, metal cave with mostly smooth surfaces made of ablated or abutted welded coated or bare steel sheets with technicians using battery or portable generator powered inspection and repair equipment. [2]

The MFL scanners are noted to already measure their own straight line distance travelled and move themselves at their own required speed, and it is emphasized that any position tracking system would be working to compliment the shortcomings of this existing system.

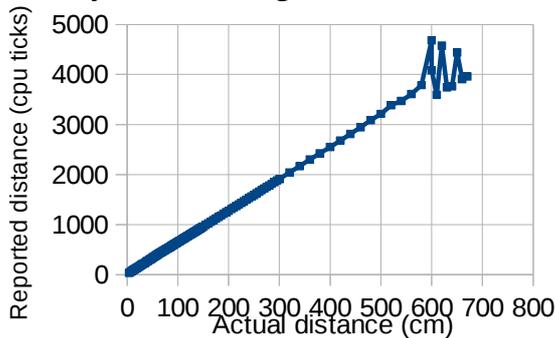
Figure 4: Demonstration of linearity and range of test system

It was then decided that this proposed system needed testing, so a test system of 1 receiver and 1 transmitter was built on a breadboard and controlled with Arduino Unos to test the range, accuracy and reliability of a single measurement. The test is carried out in an electronics laboratory, where it is found that despite the crude ultrasonic transmitter and receiver circuits, the test system performs above expectations, remaining linear, accurate and reliable over 6 meters. It should be noted that this was largely an audio engineering challenge performed by an undergraduate with no experience in audio engineering. Test results become unrepresentative as the lab the test was performed in was only 7 meters long and had immovable desks surrounding it, skewing results.

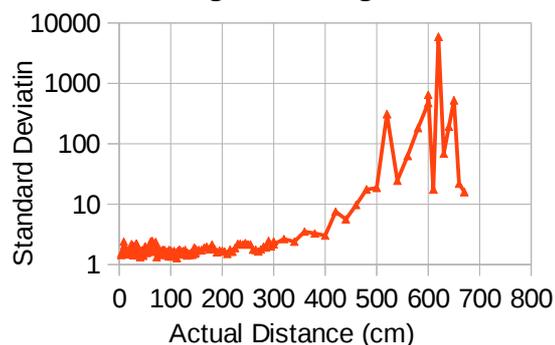
Figure 5: Standard deviation of each measurement demonstrates consistency of individual measurement (note the log scale)
